### Single pack joinery coating systems

Maintenance and service life guide

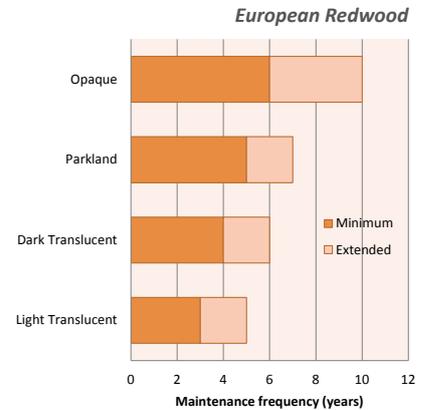
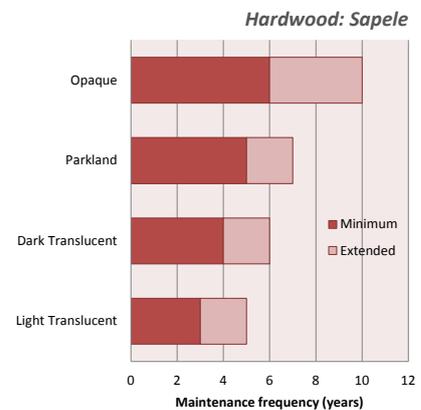
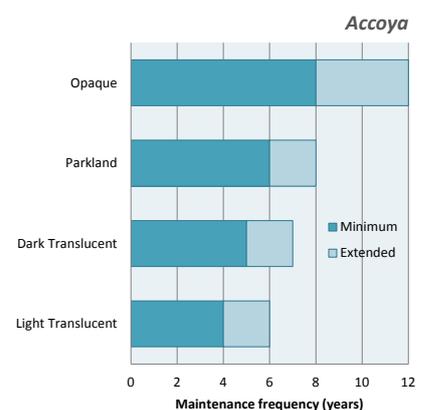
The graphs above show typical maintenance intervals for a range of coating systems applied to three typical cladding substrates

This information relates to coatings applied in the factory; to well designed timber cladding; applied at the correct film thickness; and using recommended application methods.
